# Tornado Rating Document

## Weiler (Baden-Württemberg)

07 JUN 2021

Intensity Rating: IF1- / F1 / F1T2

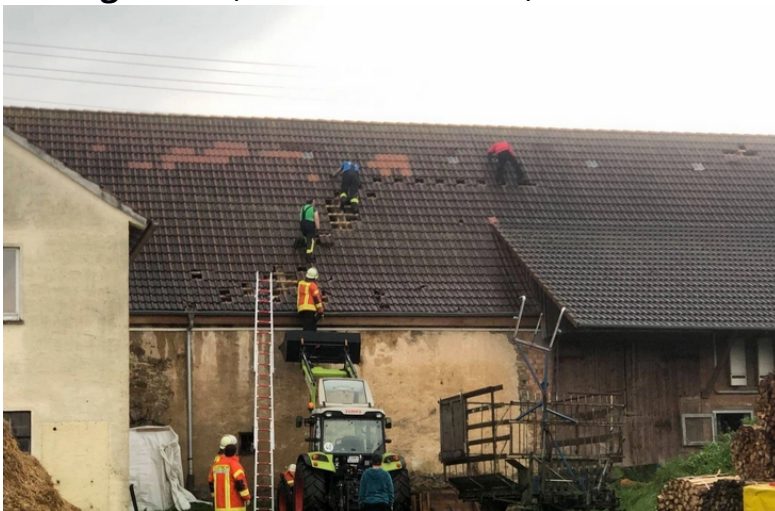
#### 01 Large barn (48.9096N 10.1772E)

Some slates blown down from the roof on the north side of the building.

DI Roofs, DoD1 (<20% loss ratio): IF0+ / F0T1.

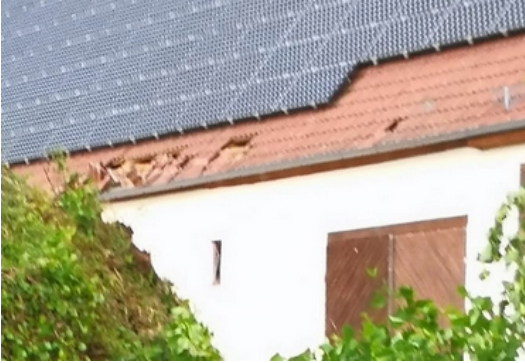
### 02 Large barn (48.9096N 10.1772E)

Some slates blown down from the roof on the north side of the building.  
DI Roofs, DoD1 (<20% loss ratio): IF0+ / F0T1.

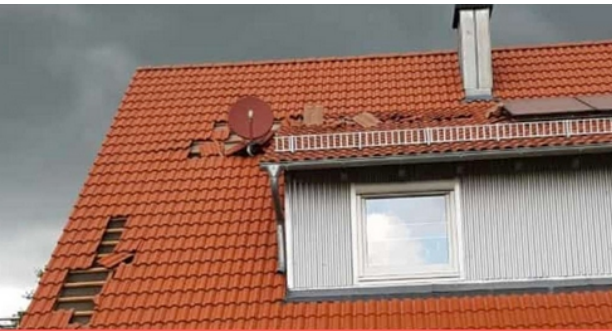
### 03 Residential building (48.9083N 10.1781E)

Some slates blown down from the roof on the north side of the building.  
DI Roofs, DoD1 (<20% loss ratio): IF0+ / F0T1.

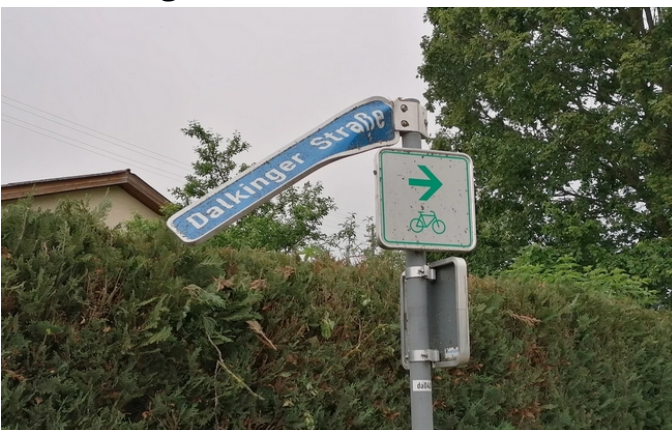
### 04 Road sign (48.9094N 10.1777E)

Damage very likely not caused by wind force, but by falling tree or large branches.
